» TEJUELO Y BIVEL CUADRADO P/PUERTA ABATIBLE

SQUARE HINGES WITH BALL BEARINGS TO WELD

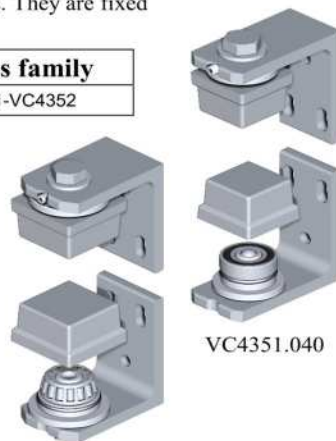
Pair of galvanized hinges with ball bearing and mounting plate suitable for tubular frames. They are fixed by welding to the frame. Fixing to the column through screws or bolts.

The table below shows each pair of hinges settings correspondent (G) and the profile size in mm.

Article Code	G	Profile Size
VC4351.040	52+62	40x40
VC4352.050	52+62	50x50

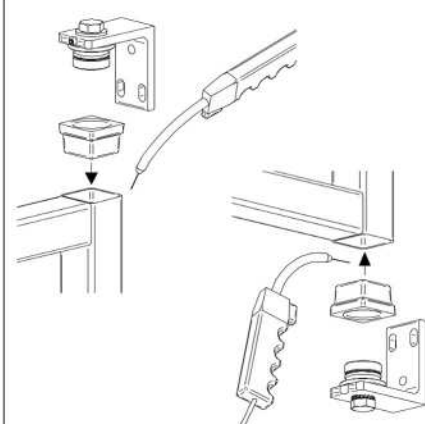
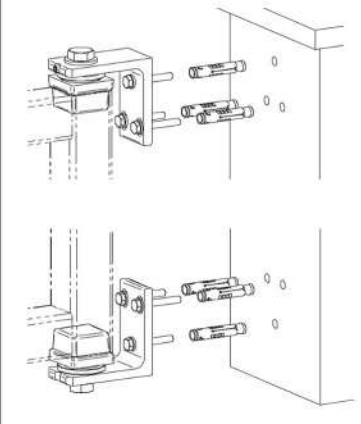
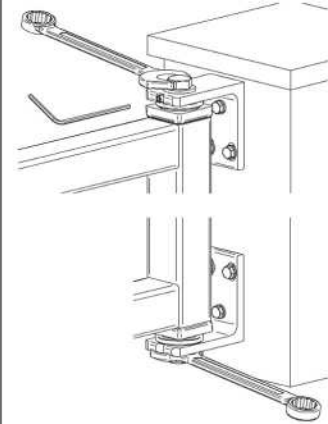
Assembly sequence.

<p>1) Insert the square inserts in the profile and weld around the edge.</p>	<p>2) Positioned the gate in the final position. Mark and drill the holes on the column. After drilling fix the hinge's bracket in place.</p>	<p>3) To adjust the gate act on the nuts and the pin.</p>

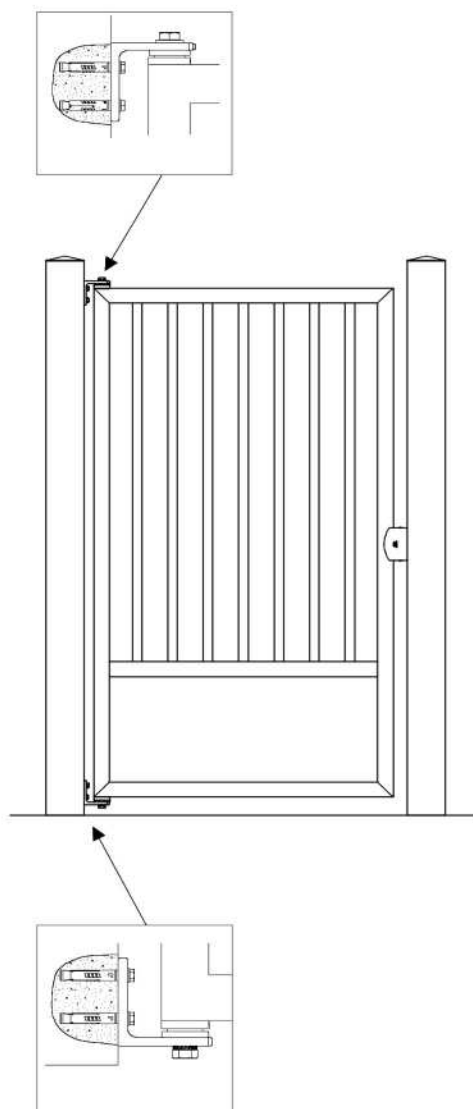
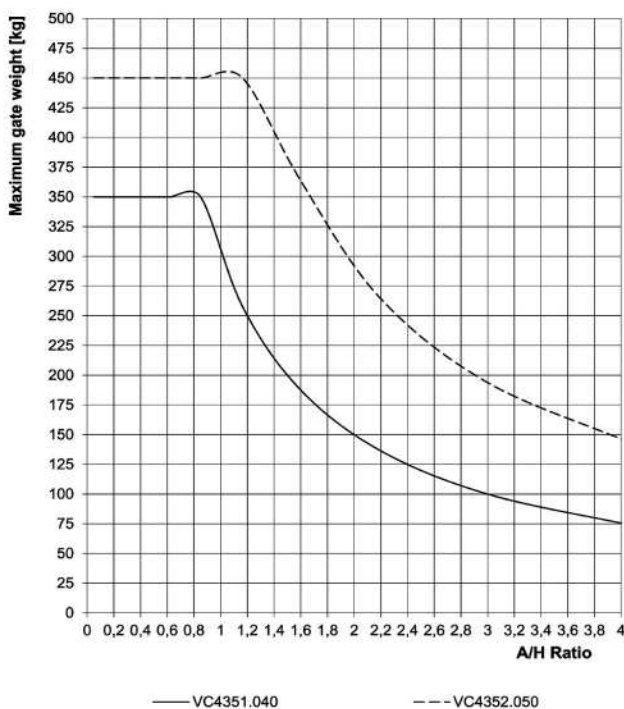
Solution fo a pair of hinges

Having calculated the A/H ratio of the gate in question (see figure) find the point in the graph that corresponds to the weight of the gate. The articles usable are those whose curve is above this point. If the weight of the gate is not distributed evenly, the value of A must be considered equal to twice the distance between the centre of gravity of the gate and the axis of rotation of the wing.
